## Case Study – A ‘Reel’ disassembly challenge - The vacuum cleaner

A Sebo vacuum cleaner was bought into the café on March 12<sup>th</sup> with a damaged mains cable about 10cm from its termination in a self-reeling drum inside the machine. The only way to repair this was to disassemble the self-reeling mechanism, cut off the 10cm of damaged cable and re-terminate the cable within the self-reeling mechanism.

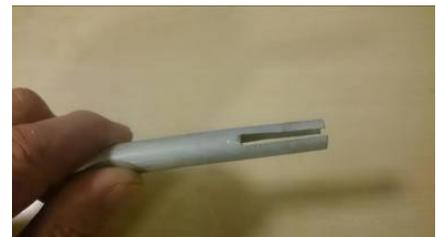
After some consideration it was decided a ‘tool’ would need to be made to get the two halves of the reel drum apart to access the cable termination. This was achieved by cutting two grooves into an odd piece of aluminium piping which happened to be exactly the right size.

The home-made ‘pawl opening tool’ was inserted inside the centre of the drum assembly to pull the four plastic pawls apart to allow the two halves of the drum to be separated.

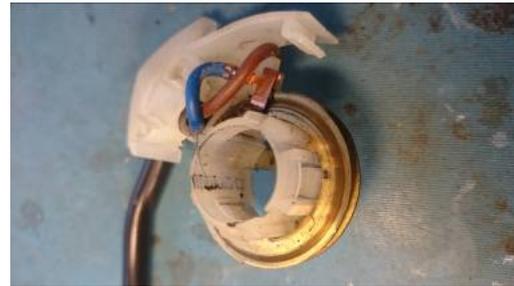
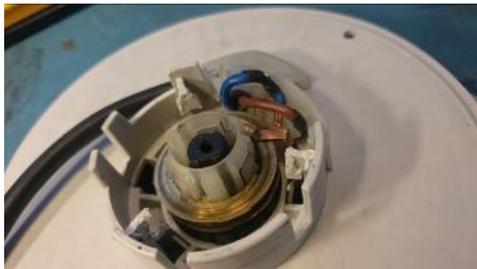
Once the reel drum had been taken apart the damaged section of cable was cut out, but to re-terminate the cable it had to be connected to the existing crimp pins used on the slip ring assembly. In the picture on the right the damaged cable is just out of shot.

The cable was cut about 20mm from the slip ring crimp pins and an in-line solder joint was made up and covered with heat-shrink sleeving. The in-line joints are not subject to stress because they are downstream from the cable clamp.
