Case Study: Repair to Kodak Carousel Projector

Peter Dobson

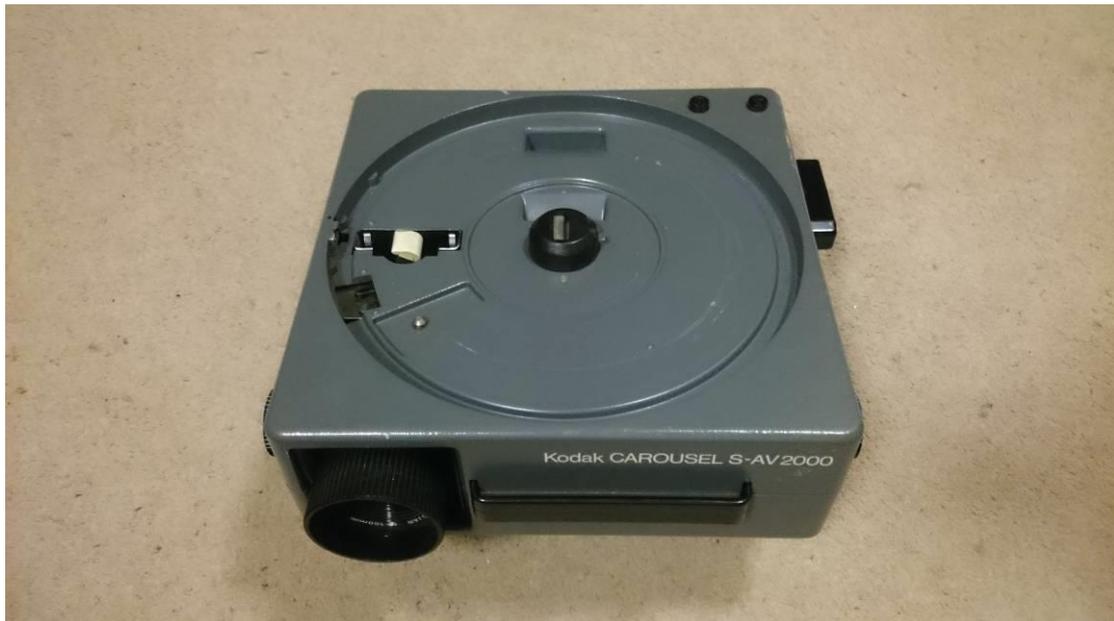
The fault symptoms on this projector were complex in as much as the mechanism would get completely confused. Sometimes it placed two slides in one carousel slot. Other times it would try and index the carousel with a slide half in and half out which would cause a jam and put lots of strain on the drive motor inside.

Inspection showed a number of problems which were uncovered progressively. Firstly the slide arm that moves the slide between carousel and projector was bent and this caused the occasional slide to jump around the side of the arm and sit half in and half out of the projector.

Repair. The arm was re-bent straight but this did not in itself cure the problem. Next it was found that the slide guide frame had become detached from the main projector frame because two 2mm peened rivets had come undone.

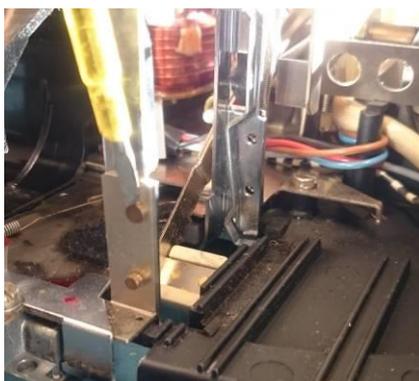
The picture shows the two peened rivets on the other side of the slide frame which are still in place, as indicated by the yellow sleeved screw driver blade.
